Kitchen Extract Report

Customer Name	KE Sample Company - 207
Customer Address	Sample Company Head Office. Sample Company Street, Sample Company Town, Sample Company County, SC1.
Site Name	KE Sample Site Name
Site Address	Sample Site Street Name. Sample Site Town, Sample Site County, SS1.
Job Ref	207
Completion Date	07/05/2025 15:27
Project Manager	Matt Parsell
Cleaned By	John Doe
Report Issued	07/05/2025 15:18

PROJECT DESCRIPTION

To internally clean the kitchen extract systems as listed below, to keep system compliant with current Health& Safety, Fire Regulations, Insurance guidelines and industry standard NAAD21 and BESA's TR19

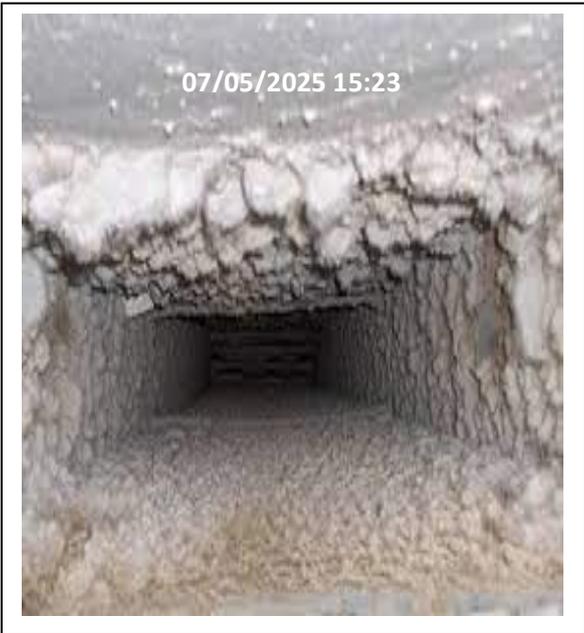
BEFORE CLEAN

Date Cleaned	07/05/2025 15:22:54
System Number	System 1
Part/Element Cleaned	Duct 1m from Canopy
Access Panel Number	1
Comments

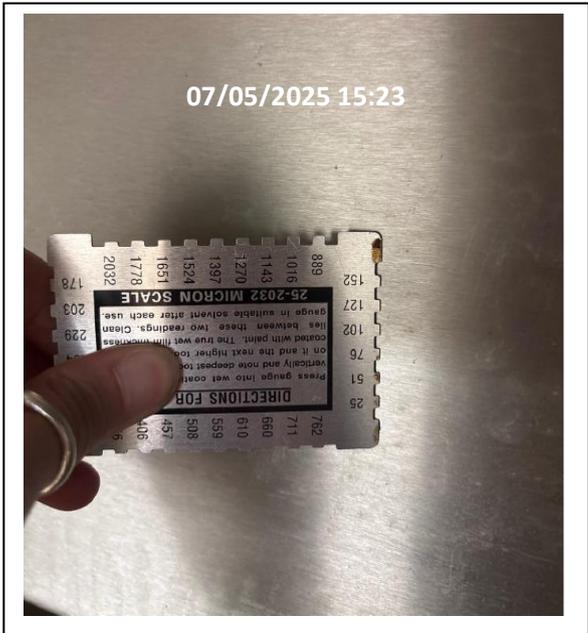
WFTT BEFORE CLEAN

System No.	Location of Test	Part Tested	Before Clean	After Clean
System 1	main kitchen	Duct 1m from Canopy	152	<25
System 1	main kitchen	Duct 3m from Canopy	127	<25
System 1	main kitchen	Duct 5m from Canopy	152	<25
System 2	main kitchen	Ductwork	152	<25

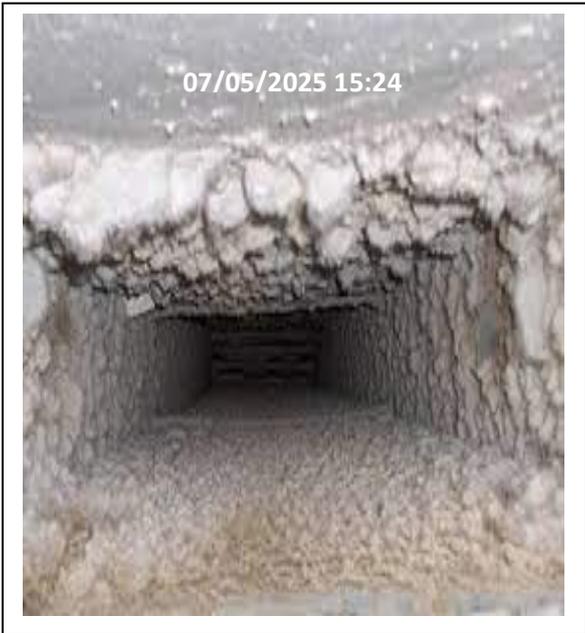
BEFORE CLEAN

Date Cleaned	07/05/2025 15:23:43
System Number	System 1
Part/Element Cleaned	Duct 3m from Canopy
Access Panel Number	2
Comments

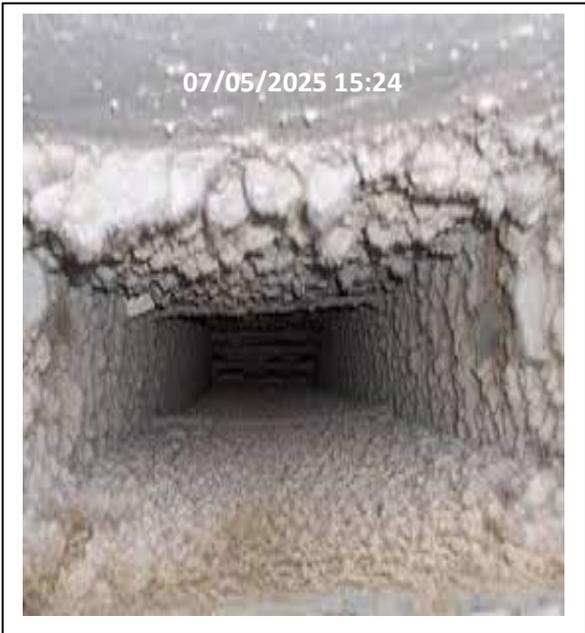
BEFORE CLEAN

Date Cleaned	07/05/2025 15:24:16
System Number	System 1
Part/Element Cleaned	Duct 5m from Canopy
Access Panel Number	3
Comments

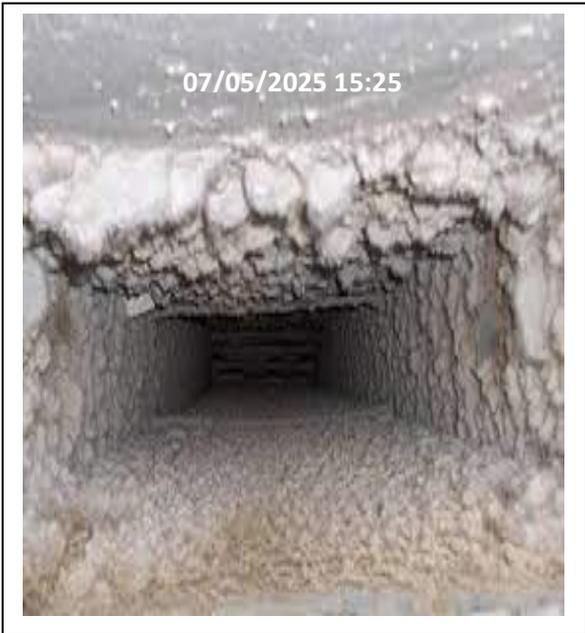
BEFORE CLEAN

Date Cleaned	07/05/2025 15:24:48
System Number	System 2
Part/Element Cleaned	Ductwork
Access Panel Number	4
Comments

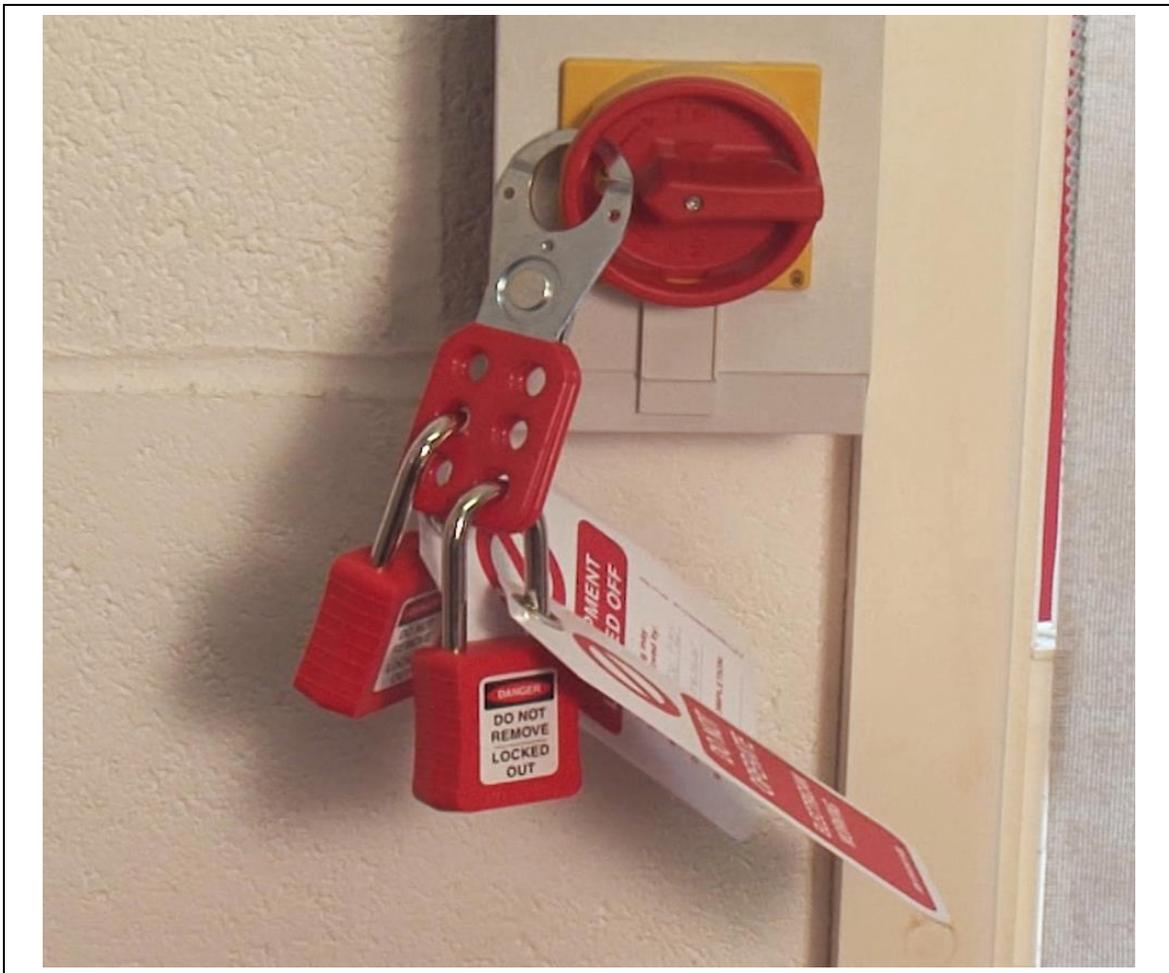
PHOTO OF SYSTEM ISOLATED

Is the Area Safe and Secure for the Public?	Yes
Is the System Running prior to arrival?	Yes
Is there an unusual noise from the Fan/Unbalanced Before the Clean?	No
Has the system been isolated and locked off?	Yes
Has any Damage been noted to Kitchen Area?	No

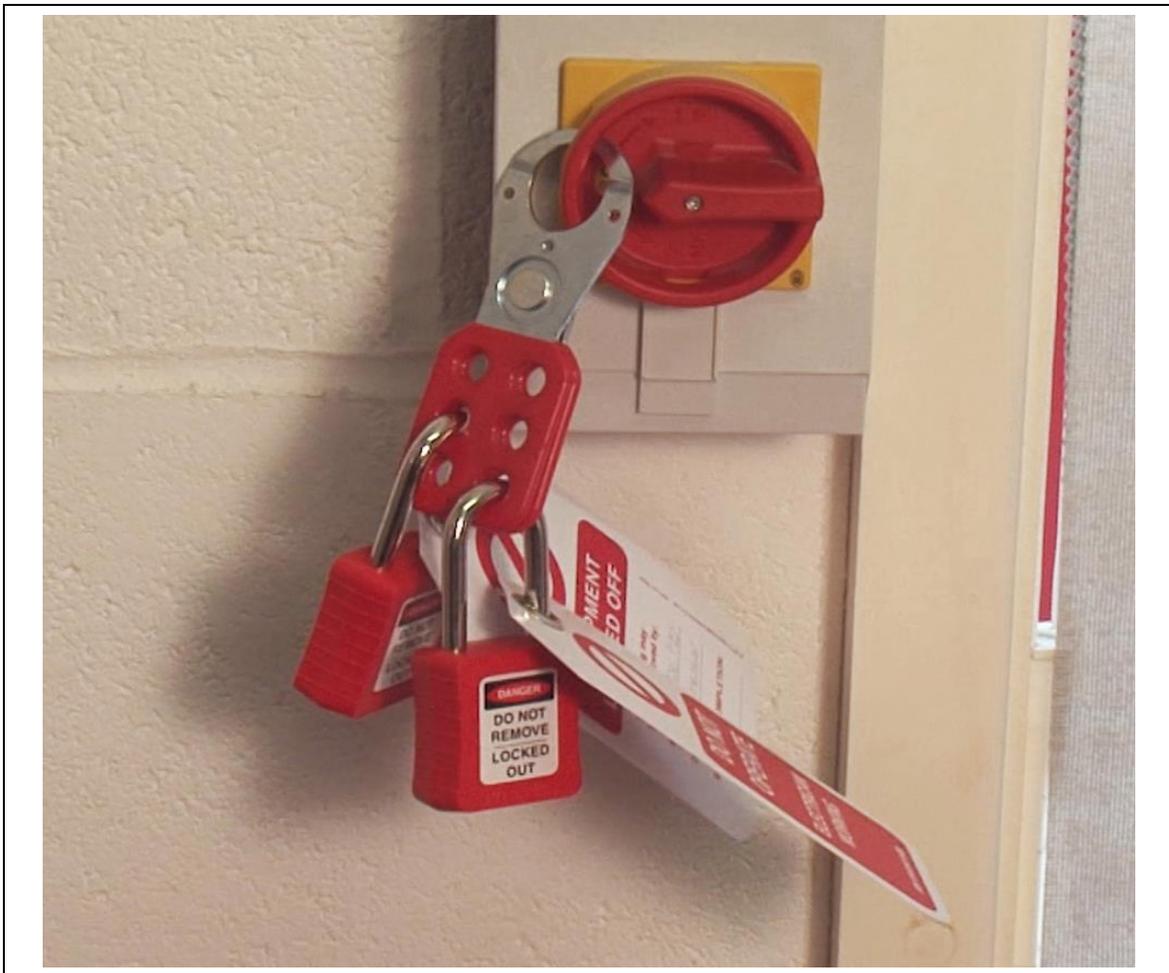
PHOTO OF SYSTEM ISOLATED

Is the Area Safe and Secure for the Public?	Yes
Is the System Running prior to arrival?	Yes
Is there an unusual noise from the Fan/Unbalanced Before the Clean?	No
Has the system been isolated and locked off?	Yes
Has any Damage been noted to Kitchen Area?	No
